AirLoader

Table of Contents

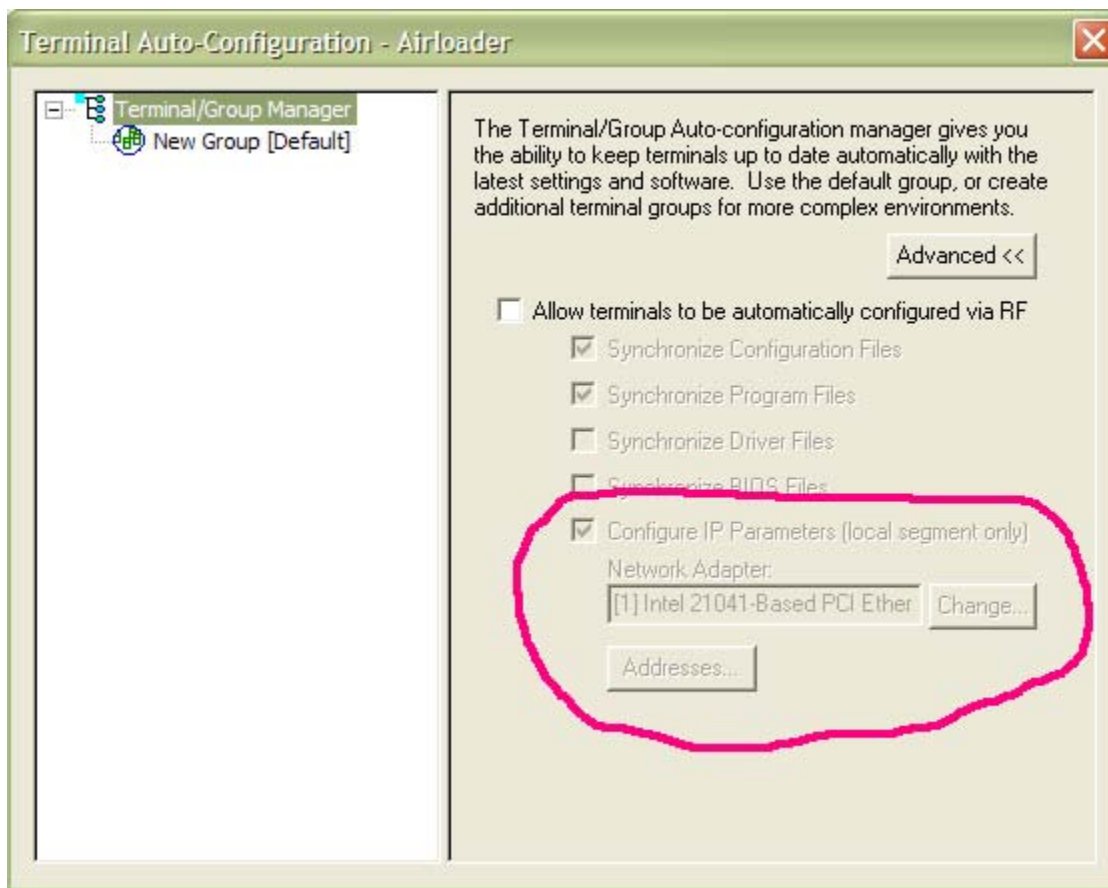
A lot of other manufacturers also use this same driver. A problem can arise if a software package installs an older version of this driver. It may work correctly for the software that installed this old version, but it usually breaks other programs that use this driver.

To test if you might have this problem, try changing the NIC adapter in the AirLoader setup. If you get a "No Adapter Found" error, you may have this problem.

You need to edit the registry to point back to the one AirLoader uses. Doing a re-install of TwinClient will not fix this. The TwinClient install will not change the driver if one is already present.

1. Using regedit, find the key titled: HKLM\SYSTEM\CurrentControlSet\Services\PCANDIS5
2. Find the value titled "ImagePath". You will probably find it set like this:
\\??\C:\PROGRA~1\Wavelink\MM\Program\PCANDIS5.SYS

3. Edit the ImagePath value to: \\??\C:\WINDOWS\System32\PCANDIS5.SYS
